Home Inspection Report

12715 NAOMILAWN DR SW, LAKEWOOD, WA 98498

Wednesday, July 18, 2018

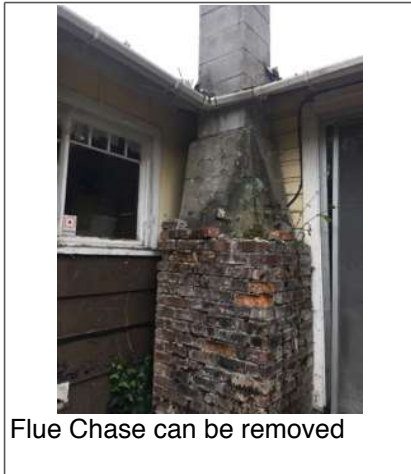
Flue Chase can be removed

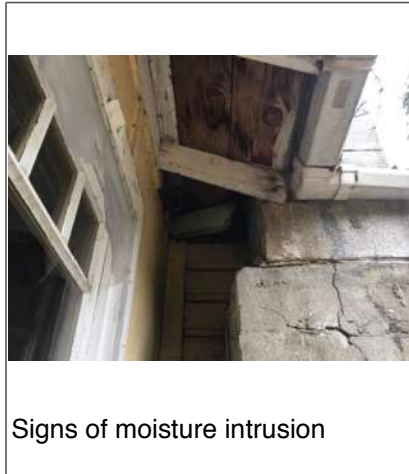
Signs of moisture intrusion

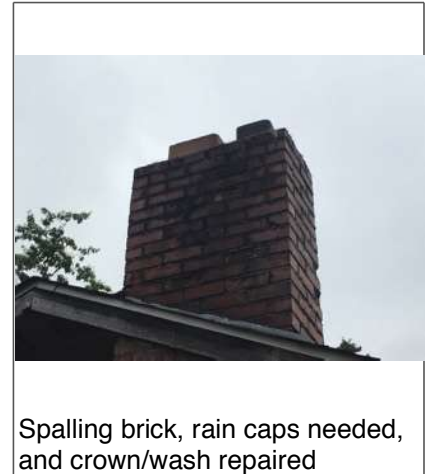
Spalling brick, rain caps needed, and crown/wash repaired

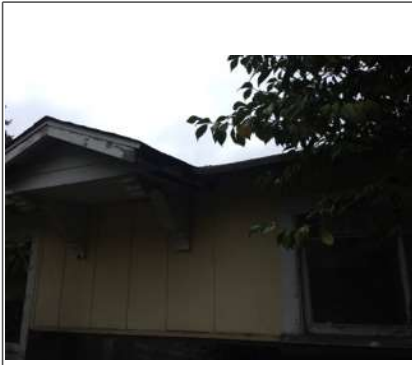
Siding and trim repair

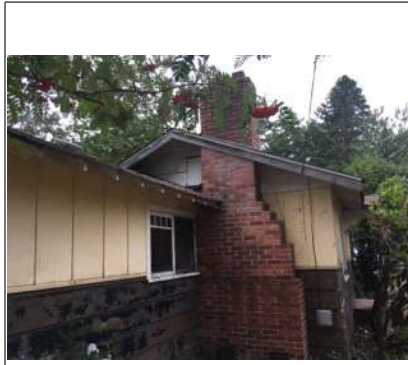
Gutters are missing

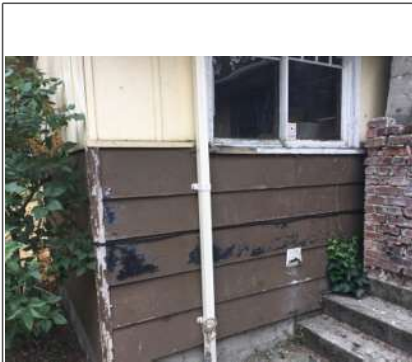
Siding and trim repair

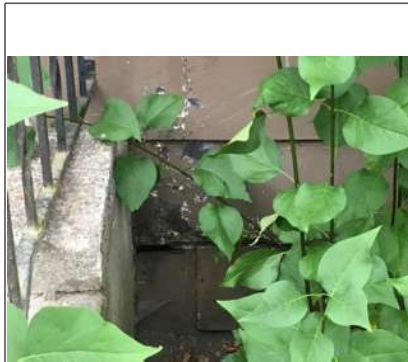
Siding and trim repair. Some of the barge Boards underlayment have damage and may also need to be replaced.

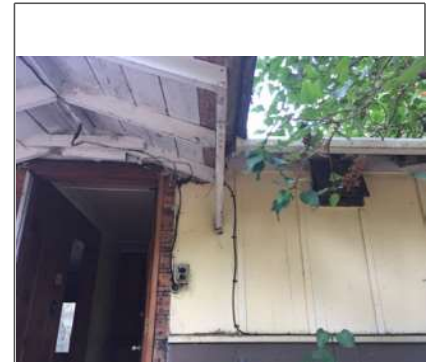
Siding and trim repair

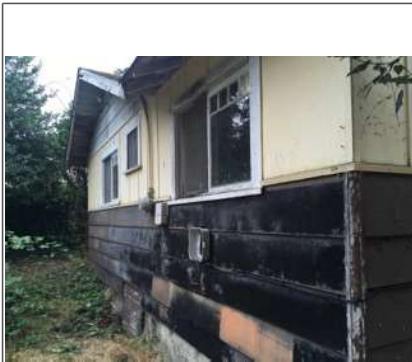
Siding and trim repair

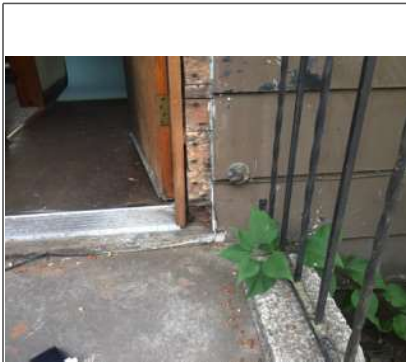
Siding and trim repair

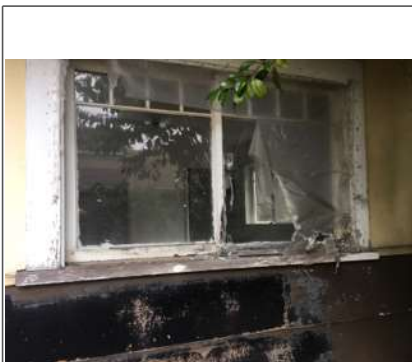
Damaged windows. Siding and trim repair

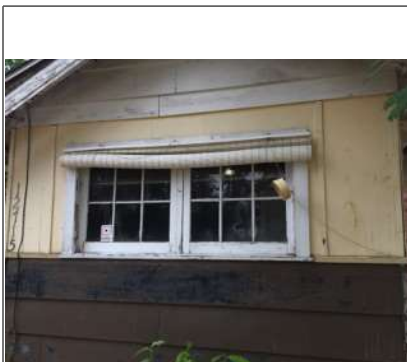
Windows need repair or replacing

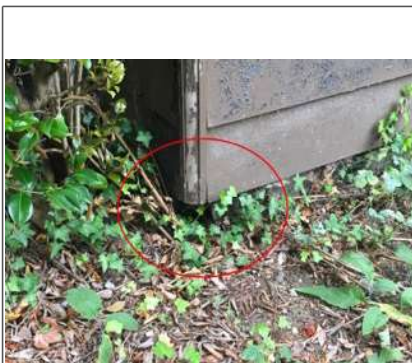
Foundation repair

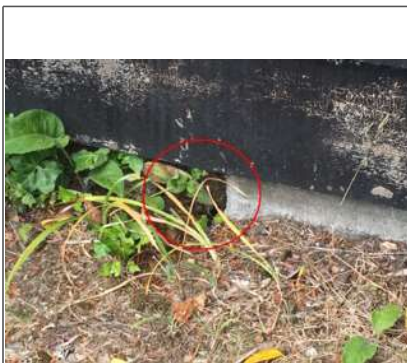
Rotted exposed beam

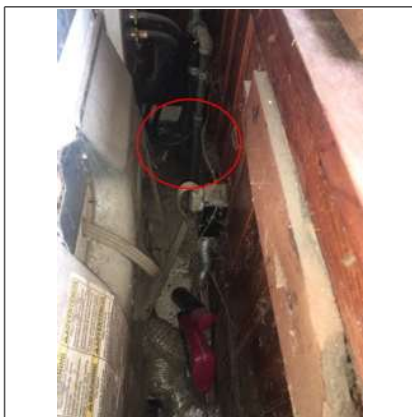
Evidence of moisture damage behind the washing machine.

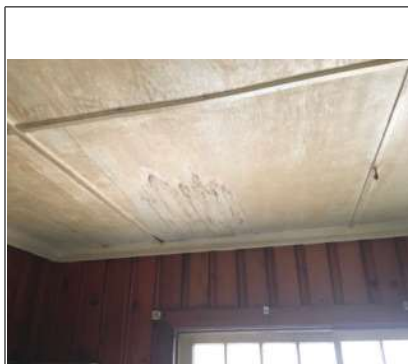
Moisture staining present on the laundry room ceiling.

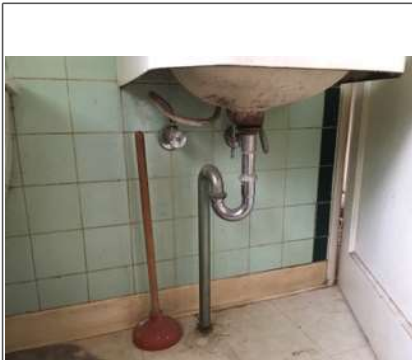
There is no P-trap underneath the sink.

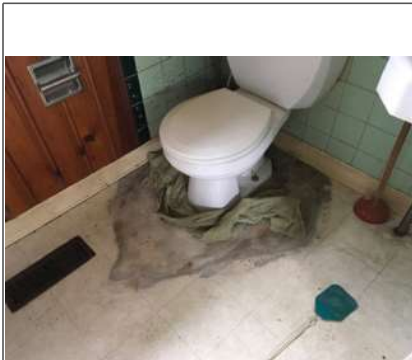
Vinyl flooring and subflooring may need to be replaced.

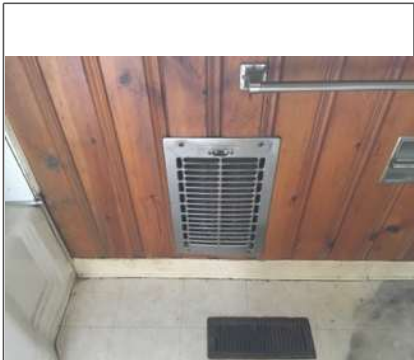
This type of wall heater has been recalled.

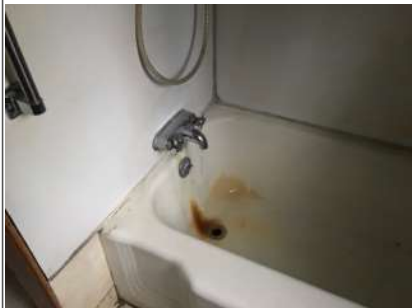
Tub is leaking severely.

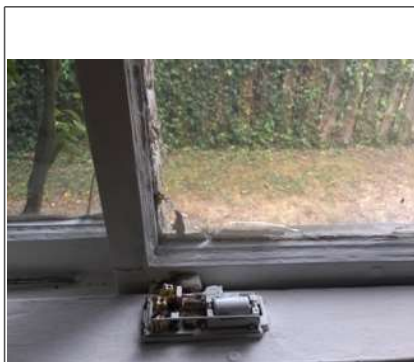
Bedroom window is cracked.

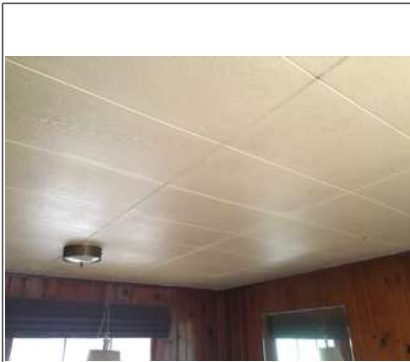
The acoustic ceiling tiles could contain asbestos.

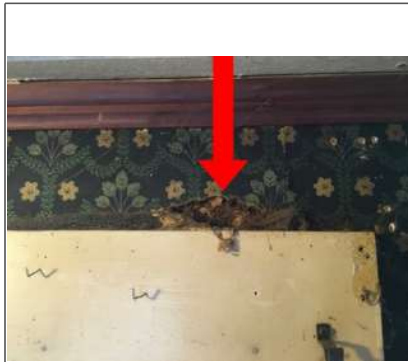
Possibility there is moisture damage wall framing on top of the sliding glass door.

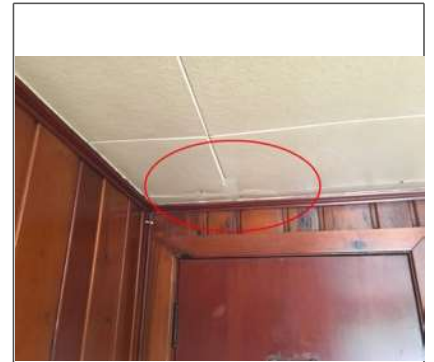
Signs of moisture intrusion above the the door that leads to nowhere.

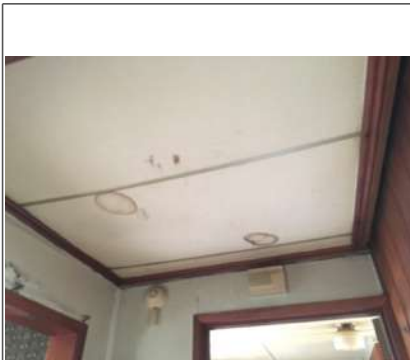
Evidence of moisture intrusion from the attic noted in the hallway.

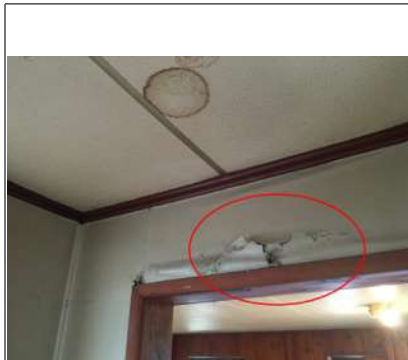
Evidence of moisture intrusion from the attic noted in the hallway.

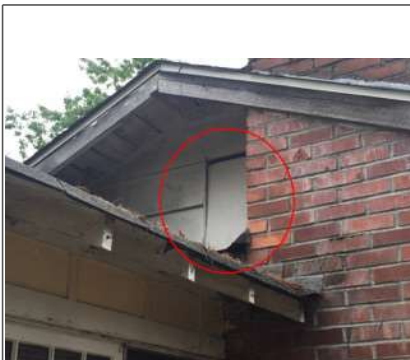
Attic access is on the exterior of the home.

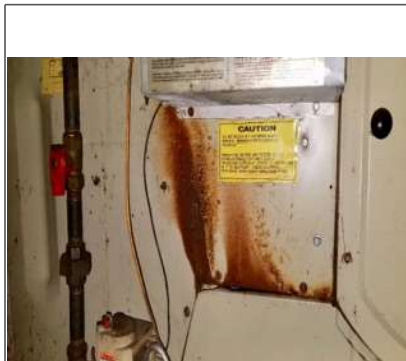
The furnace is at the end of its useful life and should be replaced.

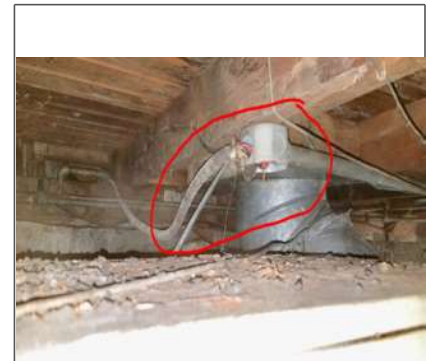
Junction boxes must have a proper cover installed

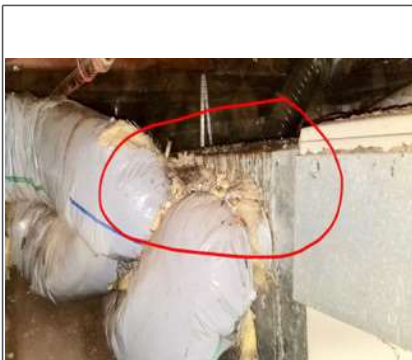
There is a large amount of rodent droppings on top of the furnace.

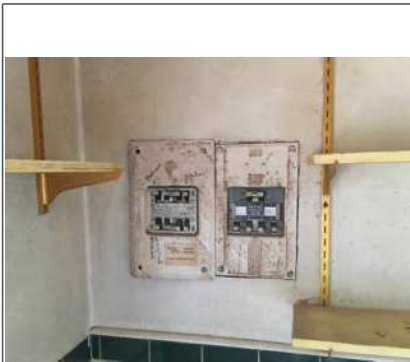
The two main service panel and wiring in the home should be replaced.

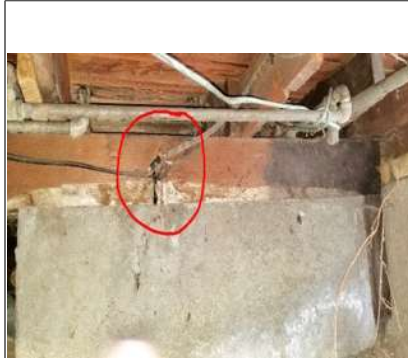
Recommend replacing the wiring in the home.

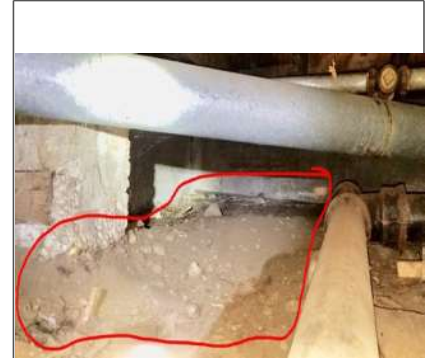
All bare earth in the crawlspace should be covered with a vapor barrier.

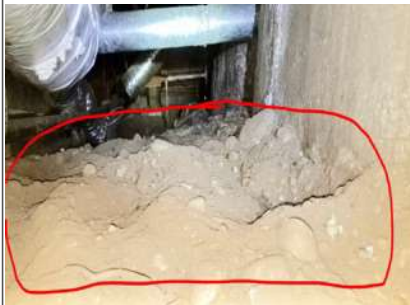
All bare earth in the crawlspace should be covered with a vapor barrier.

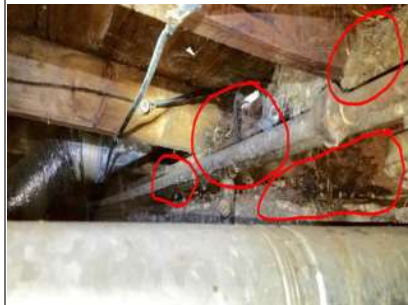
Moisture/insect damaged wall structure and floor joists.

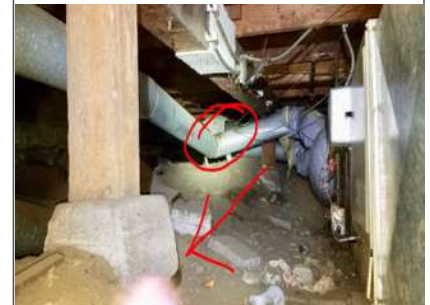
Heating duct needs to be properly supported and insulated,

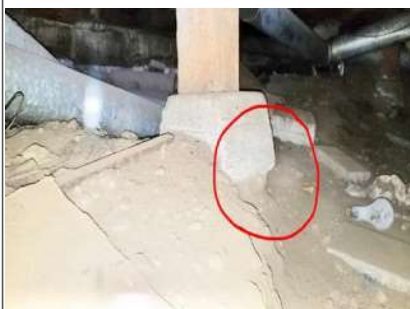
There are a couple of pier and posts systems in the crawlspace that need repair.

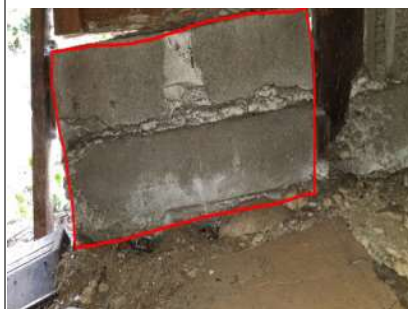
Foundation needs repair on the north side of the house.

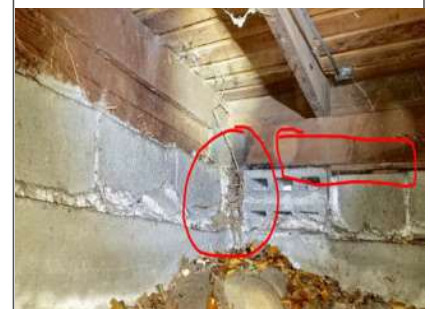
Insect damage

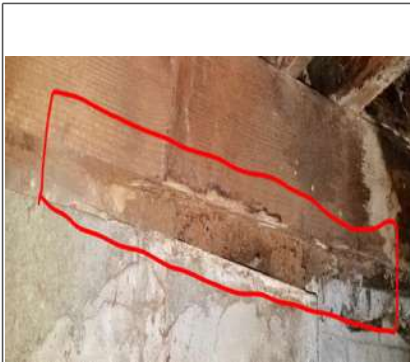
Insect damage

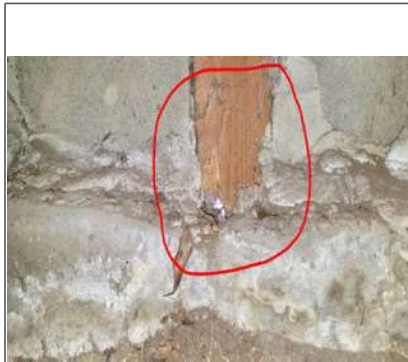
Insect damage

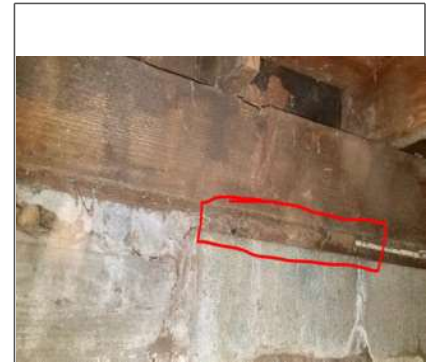
Insect damage

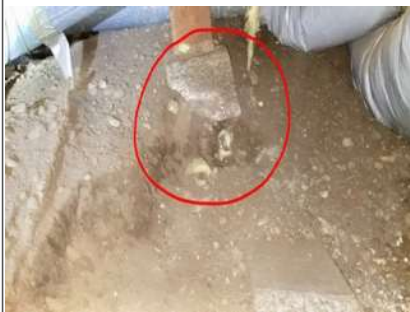
Pier and post need repair.
